1. Property Description

1.1 Basic Description: The Sons of Jacob Synagogue is found at 302 McIntyre Street West, at the intersection of McIntyre Street and Cassells Street in North Bay, Ontario. The Sons of Jacob Synagogue has been a place of worship for the Jewish community in North Bay since 1925. Built in the year 1906 or 1907 the committee's research has indicated that the building has operated as a furniture store, a grocery store, a wallpaper store and a second hand store before being established as a Synagogue (Appendix A).

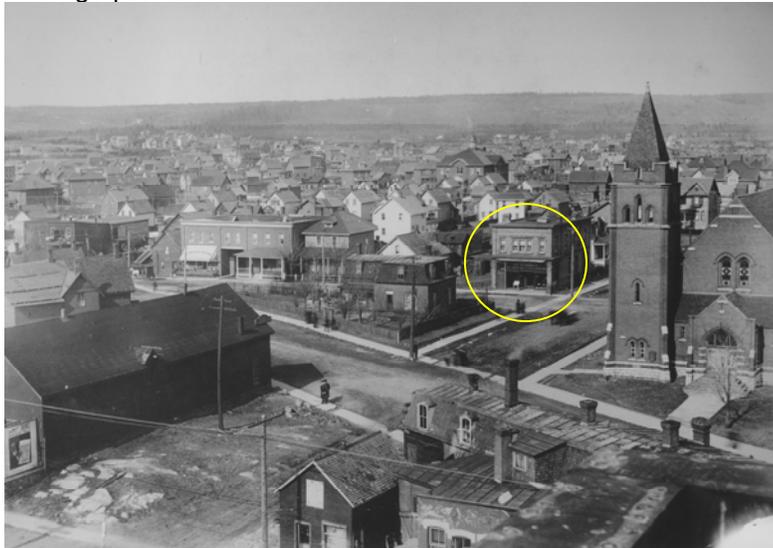
Photograph circa 1915:

Looking north-east at the intersection of Algonquin (Klock) and Cassells Street circa 1920. The proprietor appears to be J.F. Farrell and furniture appears in the storefront window.

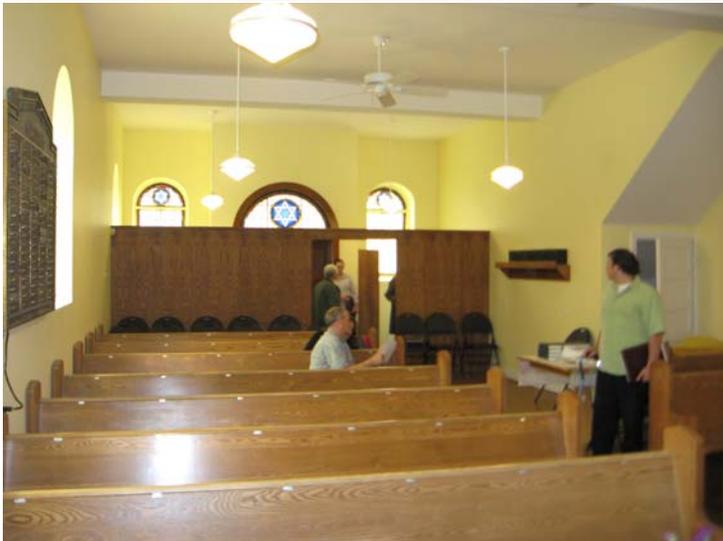
Appendix E

- The rounded windows on the front are also the primary features of the interior worship space. The stained glass window patterns, featuring a Star of David motif in the arched portion of all windows and the doors transom is quite noticeable throughout. (Appendix E)
- Many of the main floor finishes have been replaced due to the water damage. Flooring is new, and the walls and ceilings have been renewed with wall board.
- The interior furnishings are quite prominent, which include wooden pews and a refurbished bema. Much of the furnishing appear to be new, likely replaced due to damages. The owner noted that the bema had been replaced with a renewed bema styled in the same manner as the original. (Appendix F and G)
